Passive house indoor pool Bambados Monitoring

Passivhaus Institut, August 2015 2015

Address: Bambados indoor
pool Pödeldorfer Straße 174
96050 Bamberg

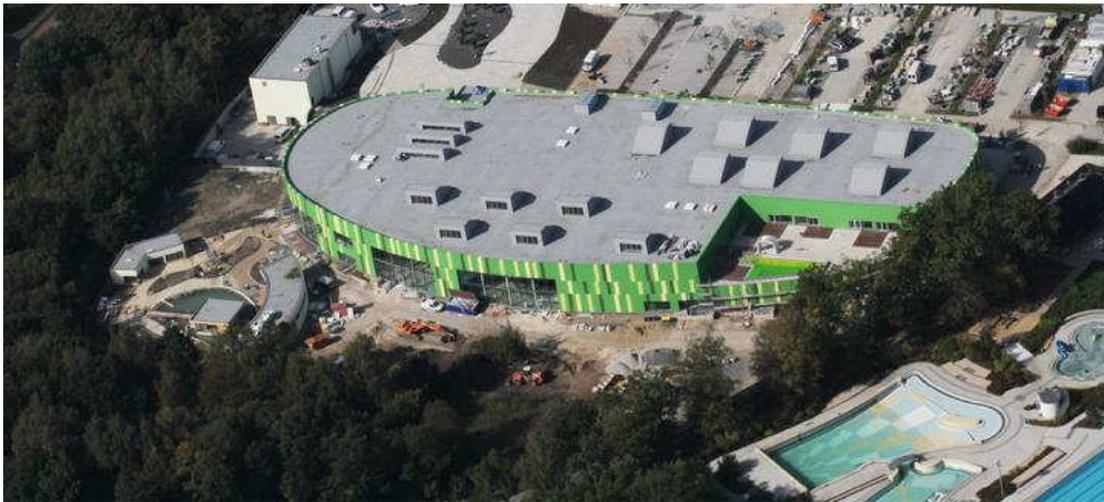
Figure 1: Aerial view of Bambados during the construction phase ; Photo: Adolf Nüßlein
(In the foreground on the right is the adjacent stadium b ad to see)

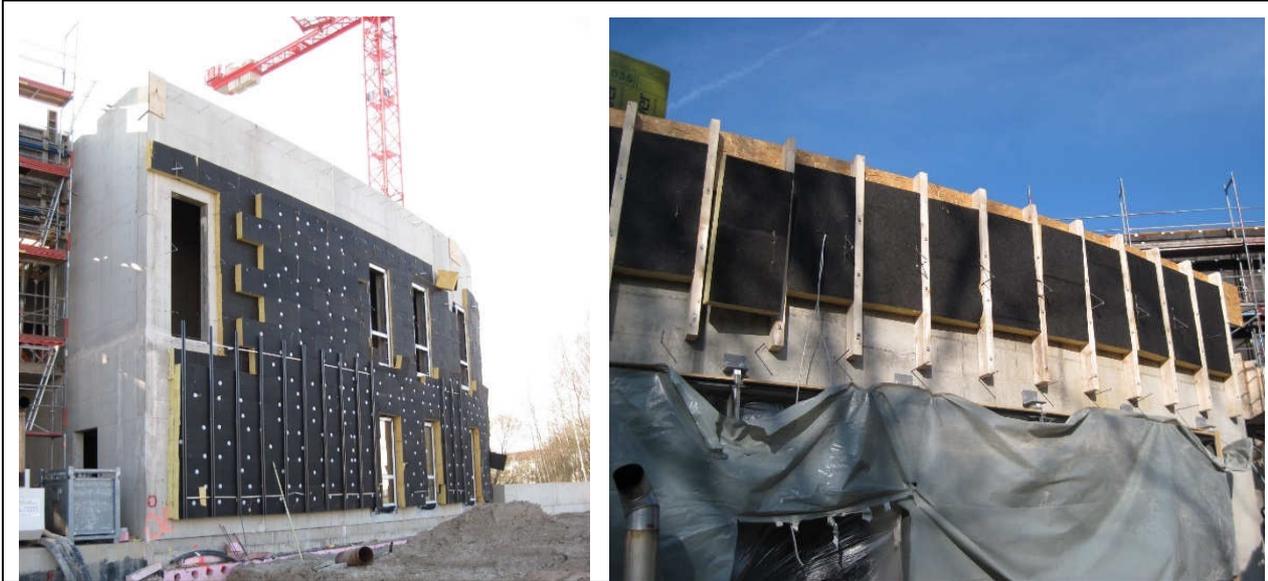
Figure 7: Wall insulation, filigree facade anchors u

nd wooden attic construction

Table 2: Component structures in Bambados

Overall component		Insulation layer		
	thickness [m]	U value [W / (m ² K)]	material	thickness [mm]	Λ [W / (mK)]
Outer wall	0.55	0.135	mineral wool	300	0.035
Outer wall against soil	0.55	0.137	XPS	300	0.042
Base plate	0.75	0.142	XPS	300	0.045
Roof (wood)	0.38	0.097	EPS / XPS + mineral wool	280 + 80	0.035 / 0.040
Roof (concrete)	0.61	0.095	EPS / XPS	360	0.035

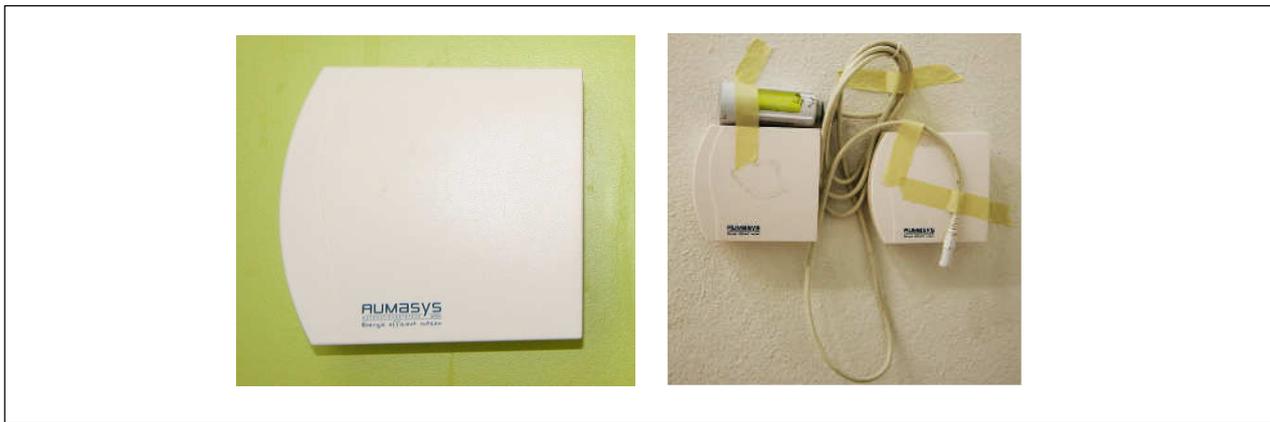
Figure 8: left: wall sensor For temperature and relative humidity, right: wall sensor with data logger for calibration (temporary)

Since the temperature and humidity readings are to be used for scientific monitoring, calibration measurements were carried out at all accessible measuring points on June 11th and 12th, 2012. For this purpose, data loggers of the type HOBO Pro v2 from Onset, previously calibrated in the climate chamber of the PHI, were used. These were attached to the respective sensor housings for measurement (measurement interval: 5 minutes) for at least one hour in order to be exposed to the same conditions as exactly as possible. This enabled 27 measuring channels to be checked and calibrated. The measured data were then compared and offset values were determined. The GLT measurement data used were offset against the corresponding offset values.

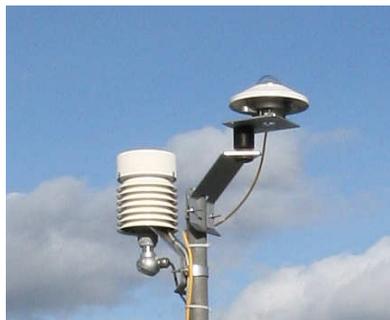
Figure 9: Weather station on the roof of the Bambados

The outside air conditions and global radiation are recorded with the help of a weather station approximately in the middle of the roof approx. 2.5 m above the roof level. A weather and radiation-protected "Hygro-Thermogeber compact" from the manufacturer Adolf Thies is used for air temperature and humidity measurement. Global radiation is measured using a CM 11 pyranometer from Kipp & Zonen BV.

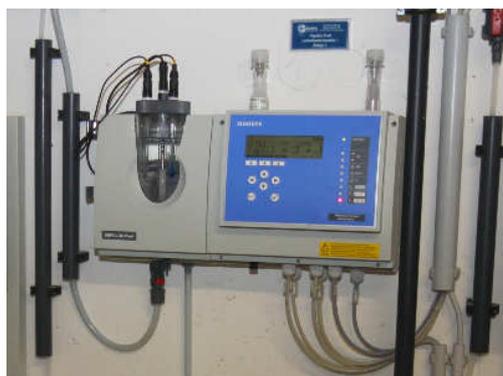
Figure 10: Chemical measuring cell for monitoring the pool water

The water temperatures of the different pools are recorded using the continuously flowing chemical measuring cell Depolox Pool from the manufacturer Wallace & Tiernan GmbH. Comparative measurements carried out directly in the individual basins showed a very good agreement with the measured values of the measuring cells.

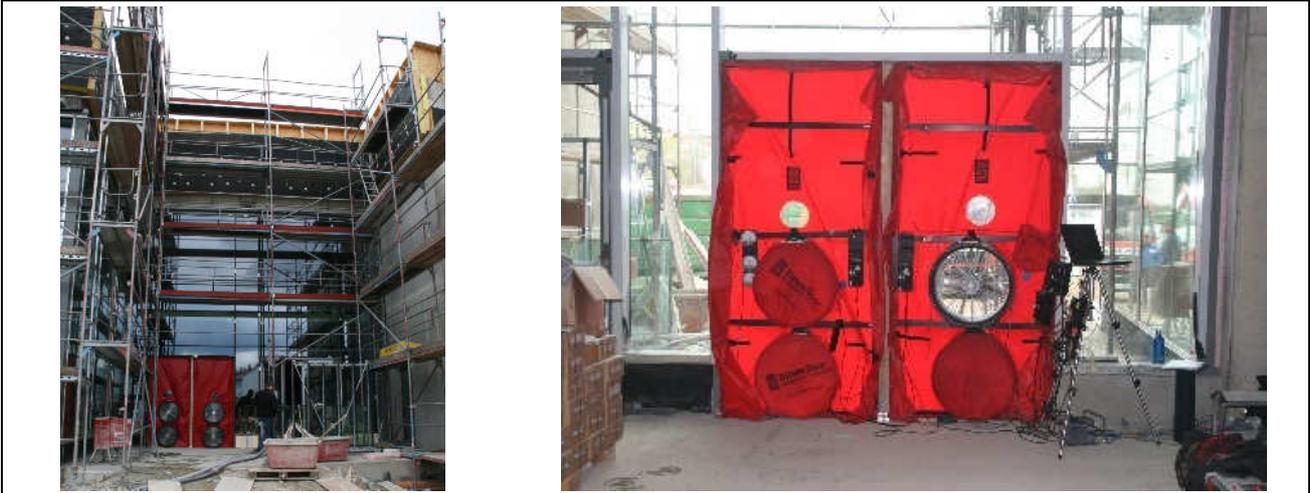
Figure 30: Airtightness measurement: the fan built-in. For the measurement of airtightness only one fan needed

s were in the area of the entrance doors despite the large interior volume

For large buildings, the q_{50} value with respect to the envelope surface is the more sensible size instead of the usual n_{50} . Value with reference to the volume of the room. The reason is the much better A / V ratio for large buildings. The entire Bambados indoor swimming pool, including the basement, has an internal volume of $61,218 \text{ m}^3$, an enveloping surface of $19,420 \text{ m}^2$ and thus a favorable A / V ratio. Because the size q_{50} . However, the value is more unusual, since the requirement value was considered n_{50} .

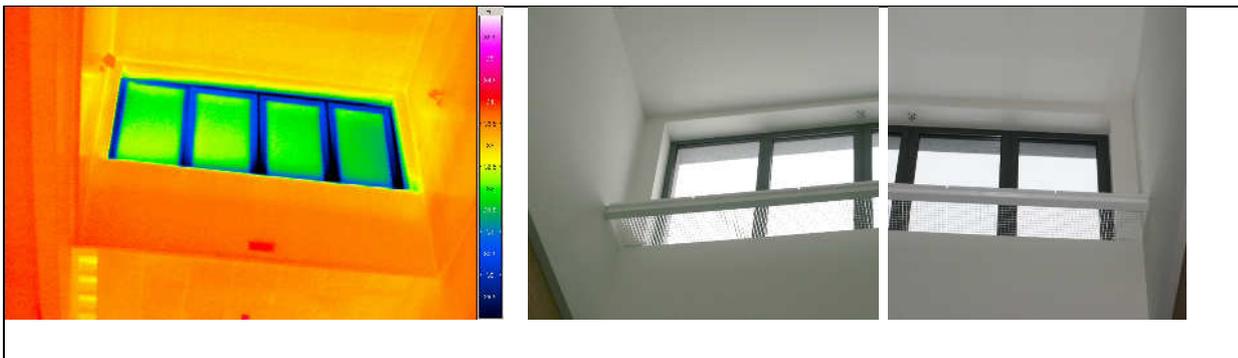
Figure 43: View of a roof shed with glazing . The photo shows the roof structure (Shed) with a grate for maintenance; the thermogram is another shed without gratings.

One of the shed-like roof structures in the leisure hall is examined as an example. Here, too, there are harmonious surface temperatures of the wall surfaces (Figure 43). The frames of the windows (from this unfavorable perspective) with temperatures well above 25 ° C are of sufficient quality to ensure that there is no condensation in the prevailing air conditions.

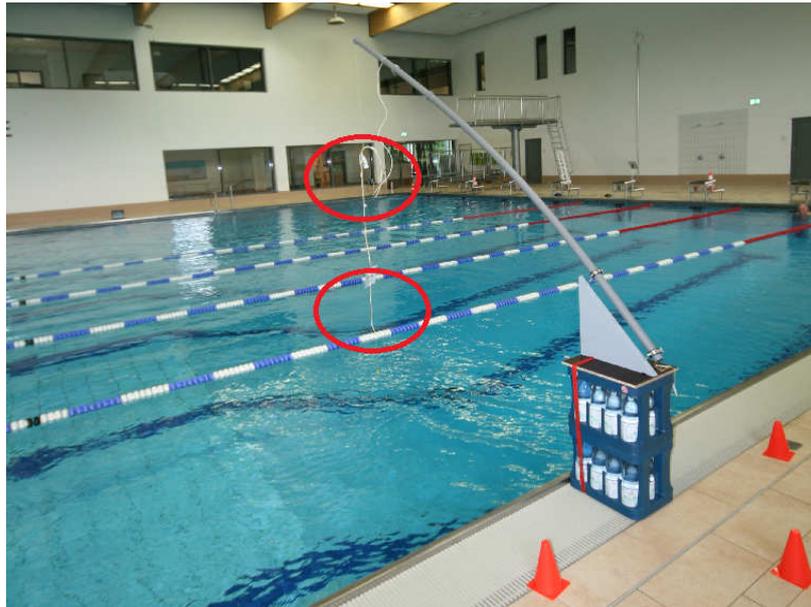
Figure 60: Measurement setup with two sensors for air temperature and humidity (red markings) at different heights above the sports pool in the Bambados

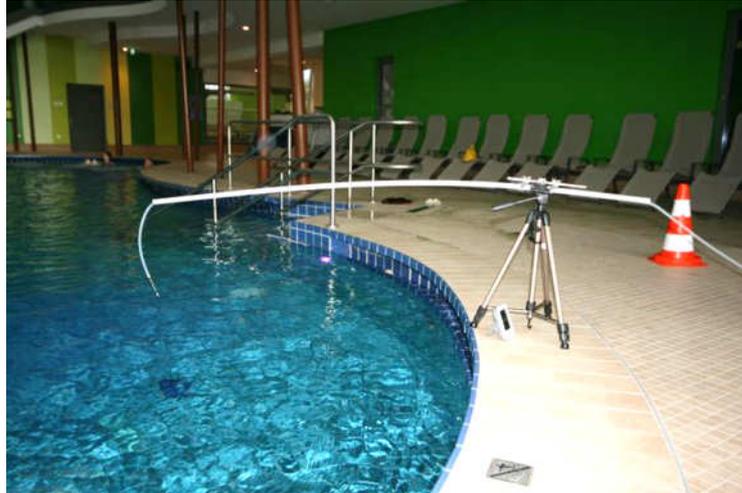
Figure 62: Measurement of trihalomethanes 20 cm
Leisure pool, air intake on activated carbon

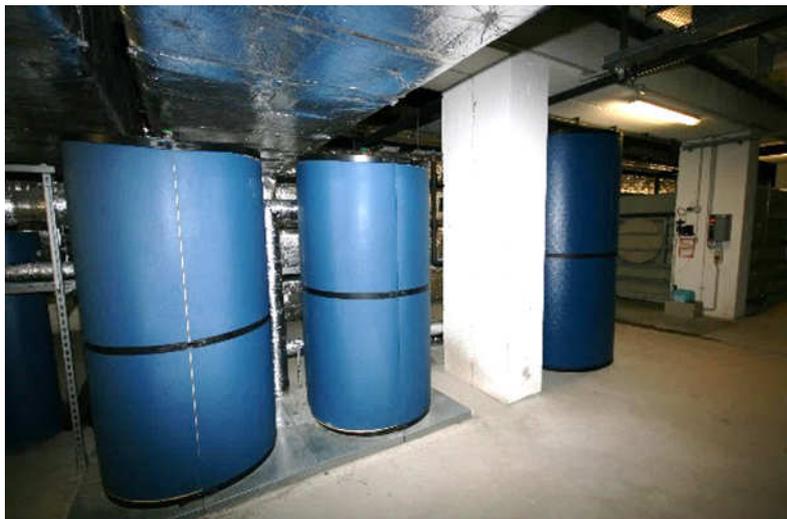
Figure 89: Three thermally insulated hot water tanks

in the technical basement of Bambado

Distributed heat exchanger / heating register for pool water, domestic hot water and the ventilation devices. Warm water is mainly used for the showers, but also in smaller quantities for the kitchen and for cleaning. There are three systems for water heating (heat exchanger with storage):

- for showers in the sports area with 500 liter storage
- for showers in the sauna area and the kitchen with 500 liter storage
- for showers in the leisure area with two 500 liter tanks. Since the storage volume was too small at peak times, a 1,000 liter storage was upgraded. This means that the peak times can be covered much better.
